Conduct inspection services

Profiler Report

Inspected section details				
Date	Road	Upstream	Direction	Downstream
Jan 12 2007	First avenue	RP-39	<<<	RP-40

Inspected section characteristic				
Network type	Material	Nominal diameter (in)	Measured diam. at the beginning (in)	Length (ft)
Sewer	Polypropylene	12.0	12.13	82.00

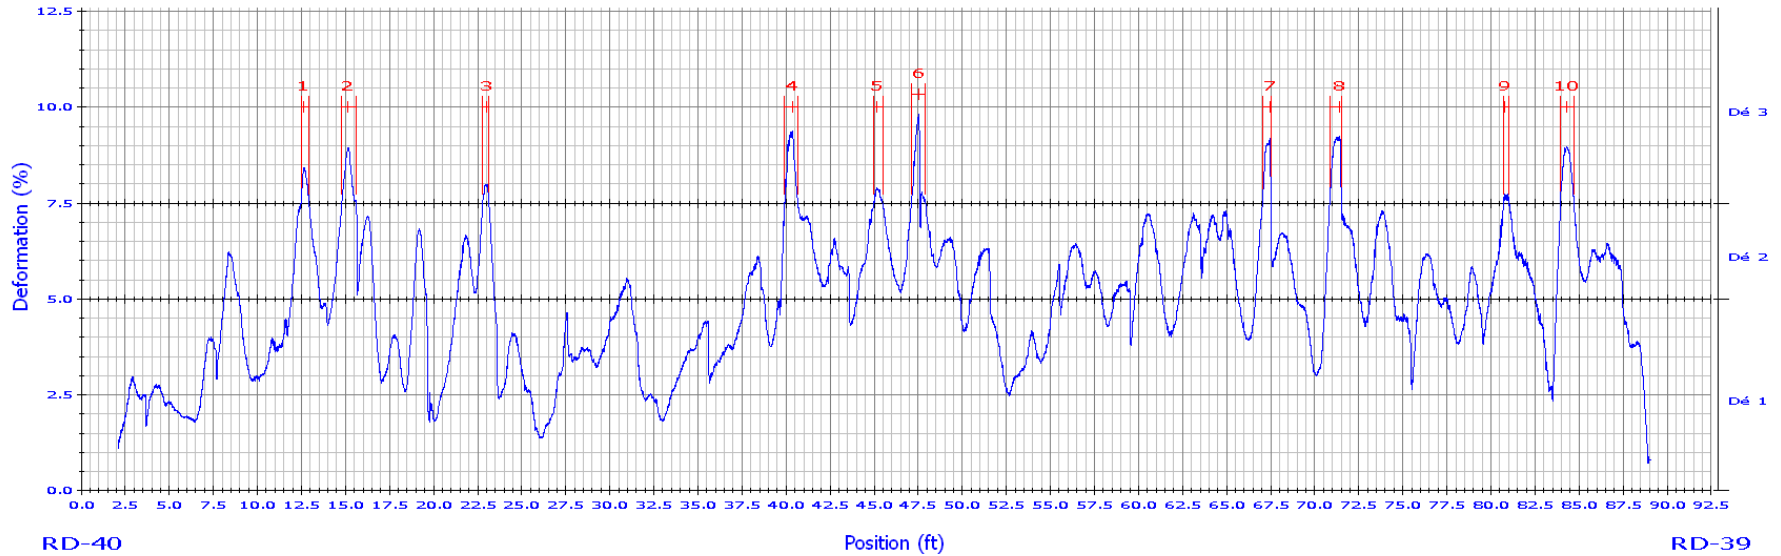
Ovalisation % (Limit 7.5%)

Observation(s)							
No.	Deformation position			Maximum deformation		Laser image	Video image
	Start (ft)	End (ft)	Length (ft)	Position	Max. Value		
1	12.51	13.08	0.57	12.72	8.43 %		
	Comment :						
2	14.72	15.63	0.91	15.08	8.95 %		
	Comment :						
3	22.75	23.07	0.32	23.02	7.98 %		
	Comment :						
4	39.89	40.72	0.83	40.38	9.37 %		
	Comment :						
5	44.98	45.50	0.52	42.12	7.82 %		
	Comment :

Observation(s)							
No.	Deformation position			Maximum deformation		Laser image	Video image
	Start (ft)	End (ft)	Length (ft)	Position	Max. value		
6	47.12	47.88	0.76	47.52	9.72 %
